Addendum to *EKirk* Southern Coach Kits

Coach Floor

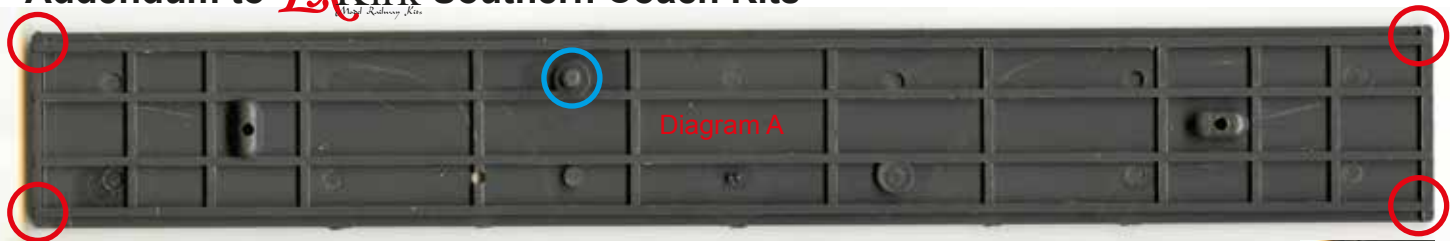
Diagram B

The Coach Floor in this kit is from a new tool, unfortunately a few errors crept in during machining of the tool. Rectifying these errors is fairly simple with a sharp craft knife. Firstly the four corners need trimming to remove the section marked in orange on diagram B, this will allow the solebar to sit properly between the coach ends. Secondly, the protruding peg marked in blue on Diagram A needs to be cleaned off back to the larger diameter so that the brake cylinders can sit properly.
